A CENTRAL FORT LUPTON HISTORIC
RESIDENTIAL SURVEY ALONG PARK,
PACIFIC, AND HARRISON AVENUES

APRIL 2018

SWCA Environmental Consultants

SWCA Cultural Resources Report No. 18-209

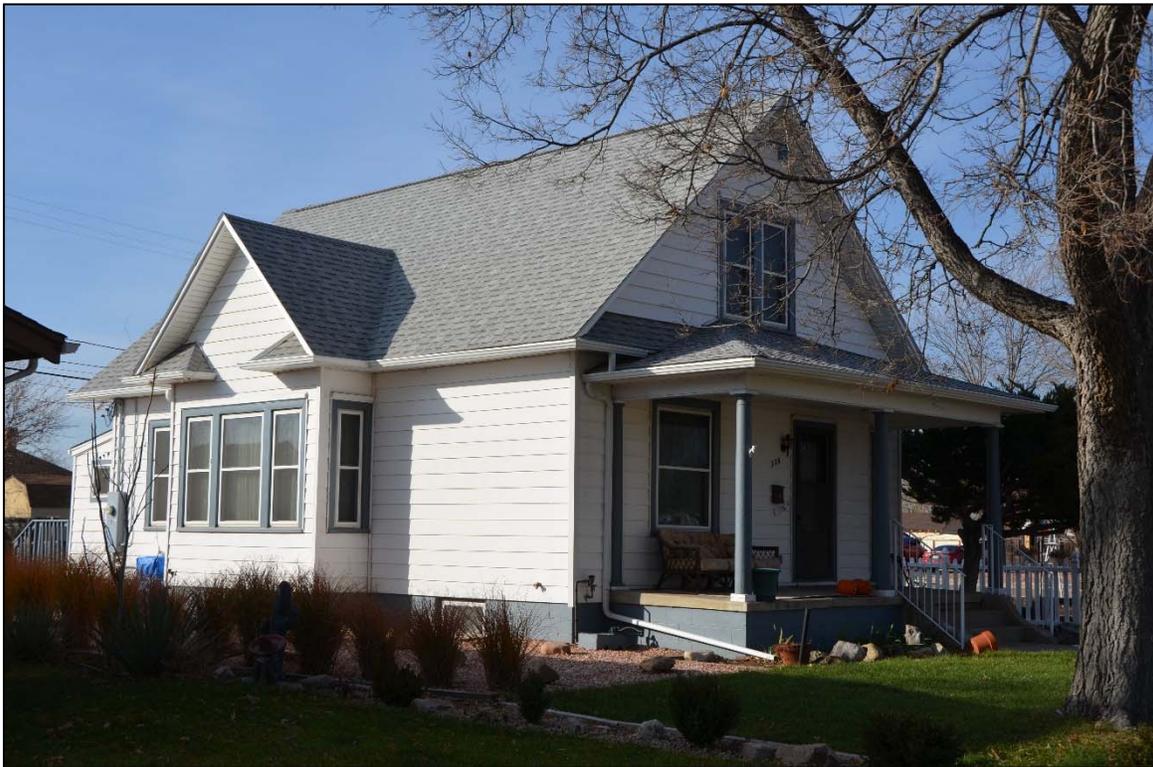
Figure 4. 229 Harrison Avenue.

raised (three steps) full-width, hip-roofed porch extending across the main façade; the roof of the porch overlaps a pent roof that encloses the front gable, and three plain Doric columns and two half-round pilasters support the porch roof. The house has a rectangular footprint with a slight bump-out on the south side formed by a rectangular bay that pushes the center bay of the south wall slightly outward, extending past the eaves with a small gable roof with asphalt-shingle-clad hipped cornice returns, a feature repeated on the rear (west) façade of the house. A single-story, one-bay-deep, shed-roof addition extends across nearly the full width of the rear façade. The front entrance of the house is located in the north bay on the east façade, in line with the front porch steps. The rear entrance is located in the south bay of the west façade and is accessed by a small modern (less than 30 years old) deck accessed by four steps. Several paired one-over-one sash windows are located throughout the house: on the second floor gable ends and centered on the north side of the house. Similarly sized single and triple windows are located on the south-facing protruding bay and one wider one-over-one sash window lights the south bay on the first floor of the main façade. Smaller single-light windows are located on the north façade and south side of the rear addition, and a single sliding window lights the center of the rear addition. The house rests on a concrete block foundation and is clad with vinyl siding. The roof is clad with asphalt shingles. The front porch and steps are constructed with poured concrete, and the rear deck is constructed with dimensional lumber (Figure 4).

The concrete block house foundation is a material commonly used at a later date than the construction of this house and therefore is likely a replacement of an original post-and-pier foundation. The poured concrete porch deck is supported by the same concrete block, so it is likely that the foundation alteration corresponds with or predates the construction of the concrete porch floor. This alteration appears to date to the mid-twentieth century.

All exterior material has been replaced except for the Doric posts on the front porch. The building foundation, probably originally post-and-pier, has been replaced with concrete block. The front porch floor and steps have been replaced with poured concrete. The siding and windows have been replaced with vinyl, and it is unclear if any other windows have been covered or if the size of the window openings has been altered. These alterations have caused loss of integrity of design, materials and workmanship. The overall loss of integrity has resulted in irreversible changes to the historic character of the building. This house therefore lacks sufficient integrity to be considered eligible for individual listing on the NRHP. However, this building was historically a component of downtown Fort Lupton's rapid growth during the early twentieth century. As with other buildings of similar design in Fort Lupton, this property is an example of a residence type common for industrial or agricultural workers, a significant demographic within the town during the period of its construction. As such, it relates to changing patterns of economic development in Fort Lupton in the twentieth century, and the residential development that occurred to meet the changing needs of the town's growing population. Despite the replacement of most of the building's historic exterior materials, it largely retains its original form. As a result, while it may not be individually eligible for the NRHP, it may be a contributing resource in a potential historic district under Criterion A.

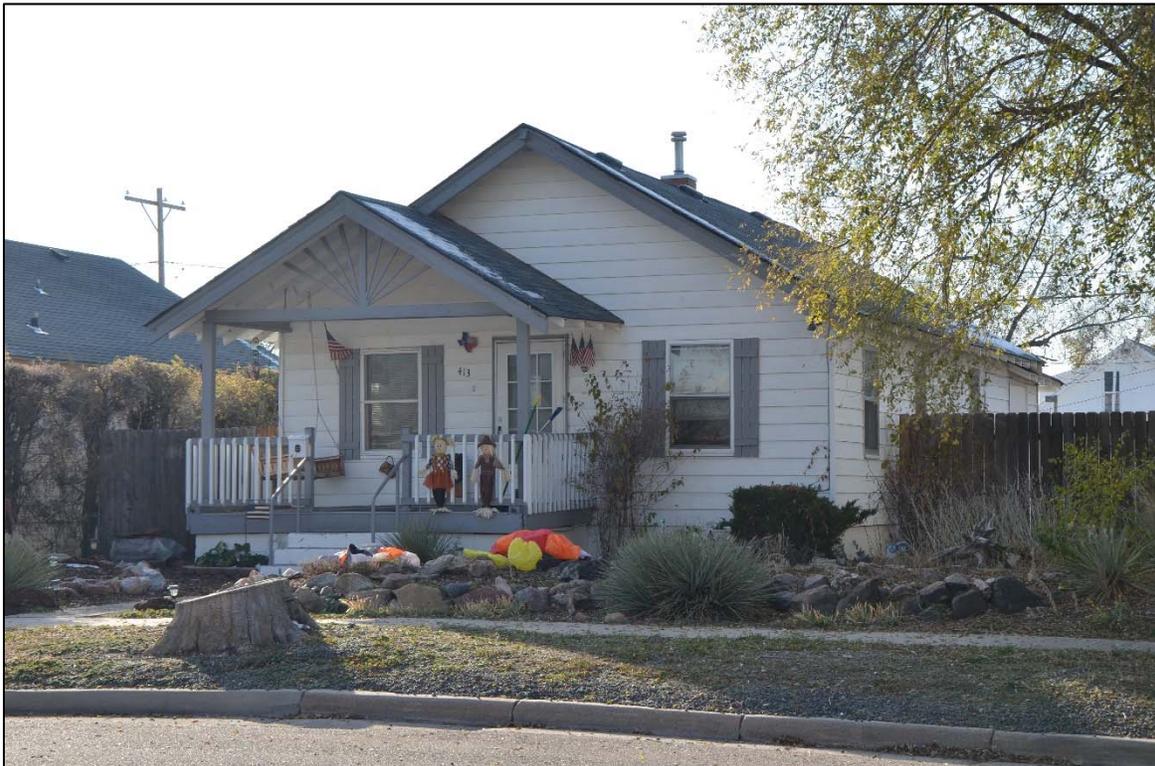
Figure 7. 413 Harrison Avenue.

This bungalow-style building is a single-story, gable-front house with a front-gable porch sheltering the south half of the façade and extending the south slope of the main roof to the south (Figure 7). A single-story hip-roofed addition extends across the rear (west) façade. The building rests on a poured concrete foundation. The front porch rail has been replaced with a modern wood (deck-style) railing. Three poured concrete steps are centered on the porch, but are not in line with the main door, which is located at the north end of the porch, near the center of the main façade. The building is clad in vinyl siding that covers or replaces the original wood siding; decorative shutters are applied to the main façade on either side of the front windows. A storm sash covers many of the windows, making it difficult to discern if the original windows exist, but at least one window on the rear façade has been replaced and another has been filled in or covered with wood; another window or vent in the rear gable end has been filled in with siding. The roof is clad with asphalt shingles.

This house was constructed ca. 1924. Recent alterations (within the last 30 years) include the replacement of all exterior materials and the replacement of the front porch rail. The original owner and occupant of the house is unknown, but by 1933, the house was occupied by William R. Terry, who in 1942 is also listed as a resident along with his wife Ollie and children Robert, Ruth, and Donnie (Fort Lupton City Directory 1933:22, 1942:14).

All exterior material has been replaced, resulting in loss of integrity of design, materials and workmanship. Although the building form is recognizable as an early twentieth century residential building, it does not retain sufficient integrity to convey its significance. This house lacks sufficient integrity to be considered eligible for individual listing on the NRHP. Due to significant alterations to the exterior of the building outside of the historic period it also lacks sufficient integrity to be a contributing resource to a potential historic district.

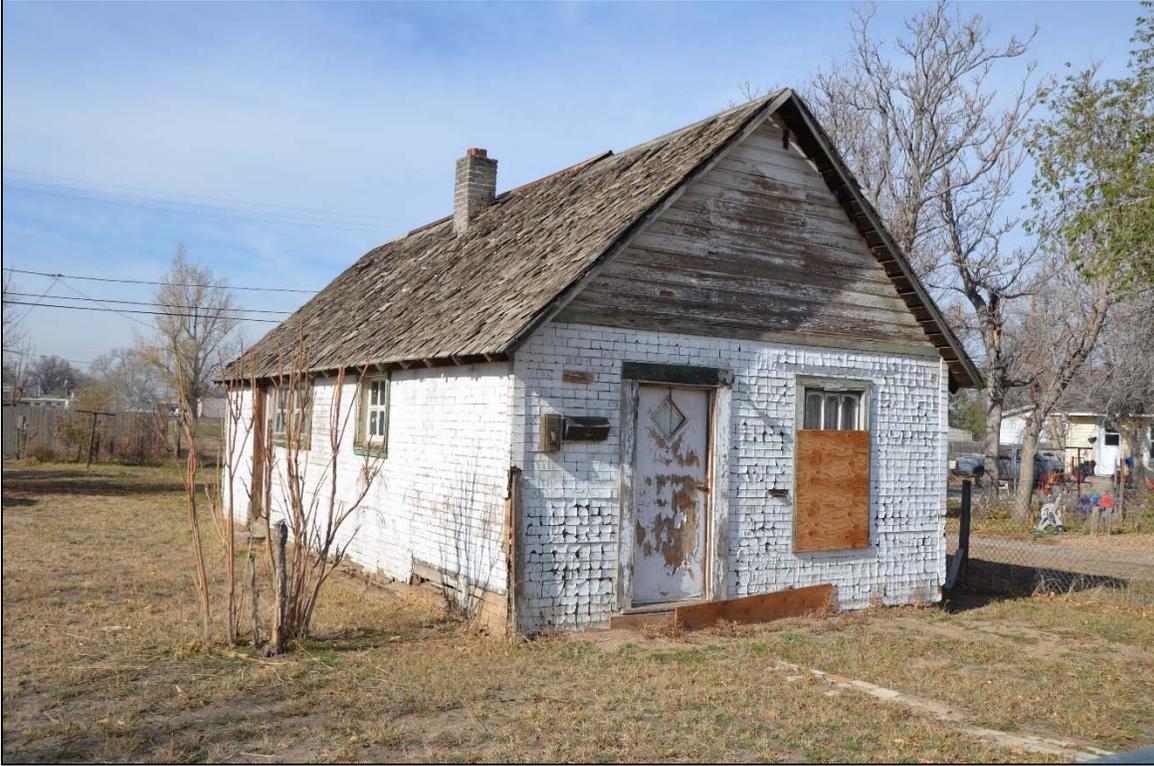
Figure 10. 727 Harrison Avenue.

Alterations include the addition of asphalt shingle siding and plywood covering several openings and the foundation in several areas. The front door has been replaced. The plywood was added after an assessment in 2009; a photograph from that year shows the property with un-boarded windows. The dates of these alterations are unknown but appear to be more than 30 years old.

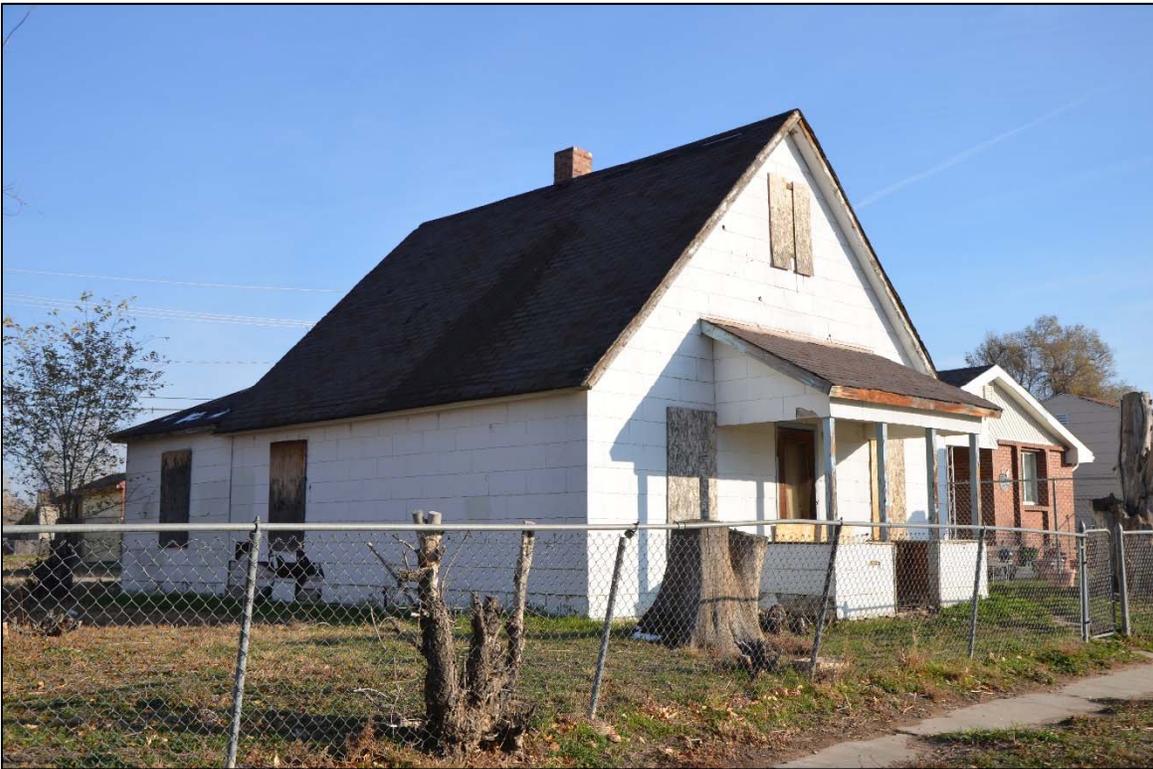
Figure 11. 810 Harrison Avenue.

This building is associated with Criterion A for its contribution to the history of residential development of Fort Lupton. However, it lacks historical integrity due to the replacement or alteration of nearly all exterior building materials. As a result, it is not individually eligible for the NRHP under any criterion.

All exterior material has been replaced or covered, but intact windows may exist under the plywood coverings. The building has lost integrity of materials due to the replacement of siding, but this alteration occurred more than fifty years ago. This house lacks sufficient integrity to be considered eligible for individual listing on the NRHP. The building is associated with NRHP Criterion A for its contribution to the history of residential development of Fort Lupton. This building was historically a component of downtown Fort Lupton's rapid growth during the early twentieth century. As with other buildings of similar design in Fort Lupton, this property is an example of a residence type common for industrial or agricultural workers, a significant demographic within the town during the period of its construction. As such, it relates to changing patterns of economic development in Fort Lupton in the twentieth century, and the residential development that occurred to meet the changing needs of the town's growing population. The building has been altered, such as by the installation of asbestos siding, and as a result it lacks sufficient integrity to be individually eligible for the NRHP. These alterations fall within the period of significance for the potential historic district, however, and as a result it may be contributing resource within a potential historic district.

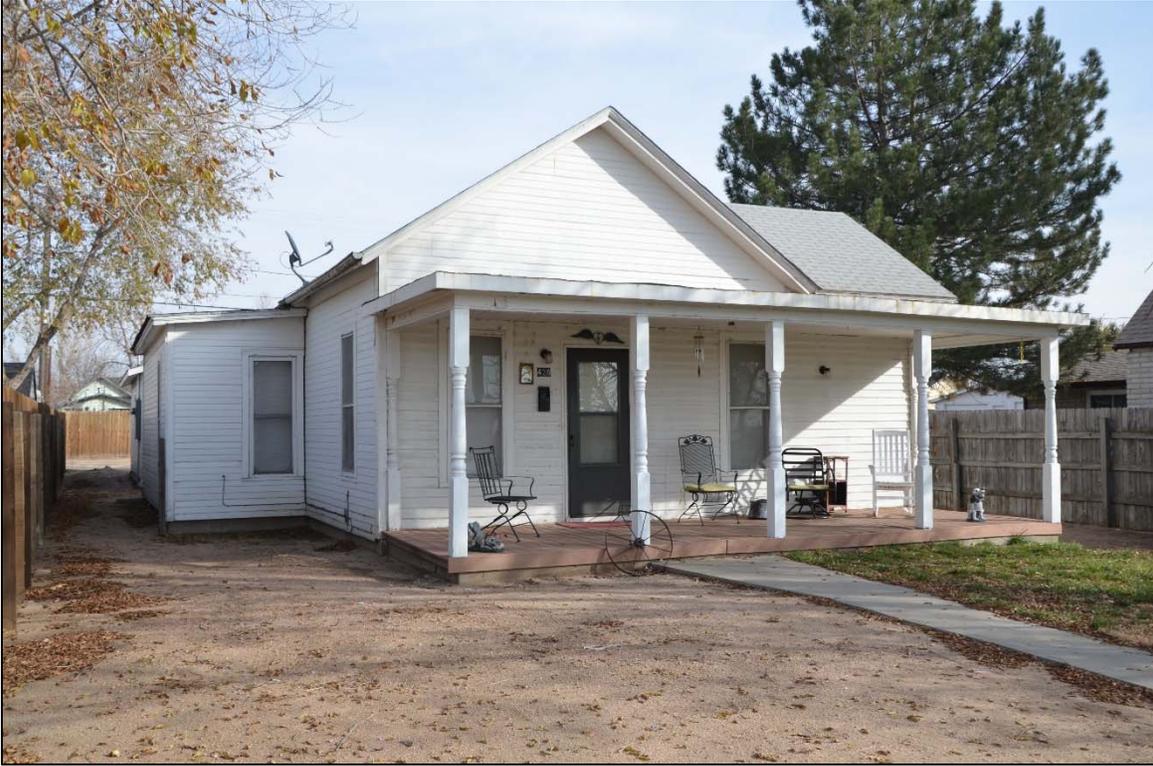
Figure 14. 428 Pacific Avenue.

The earliest alterations on the building are the addition of two shed-roofed rooms on the north and south sides; these additions appear to have been built in the early twentieth century. A rail and partial enclosure of the south end of the porch was removed sometime after 1987 (Weld County Assessor 2018).

of Fort Lupton. However, it lacks historical integrity due to the replacement of many exterior building materials and the alteration of the front porch. As a result, it is not individually eligible for the NRHP under any criterion. The replacement of the exterior cladding material and alteration of the front porch have caused loss of integrity of materials. This house lacks sufficient integrity to be considered eligible for individual listing on the NRHP. Although the building has undergone exterior alteration and is not individually eligible for the NRHP as a result, the overall form of the building (with the possible exception of its porch), as well as its design and layout, remain consistent with its historic appearance and function. As a result, it retains sufficient integrity to convey its significance as a contributing resource in a potential historic district. This building was historically a component of downtown Fort Lupton's rapid growth during the early twentieth century. As with other buildings of similar design in Fort Lupton, this property is an example of a residence type common for industrial or agricultural workers, a significant demographic within the town during the period of its construction. As such, it relates to changing patterns of economic development in Fort Lupton in the twentieth century, and the residential development that occurred to meet the changing needs of the town's growing population. Despite the replacement of most of the building's historic exterior materials, it largely retains its original form. As a result, while it may not be individually eligible for the NRHP, it may be a contributing resource in a potential historic district.

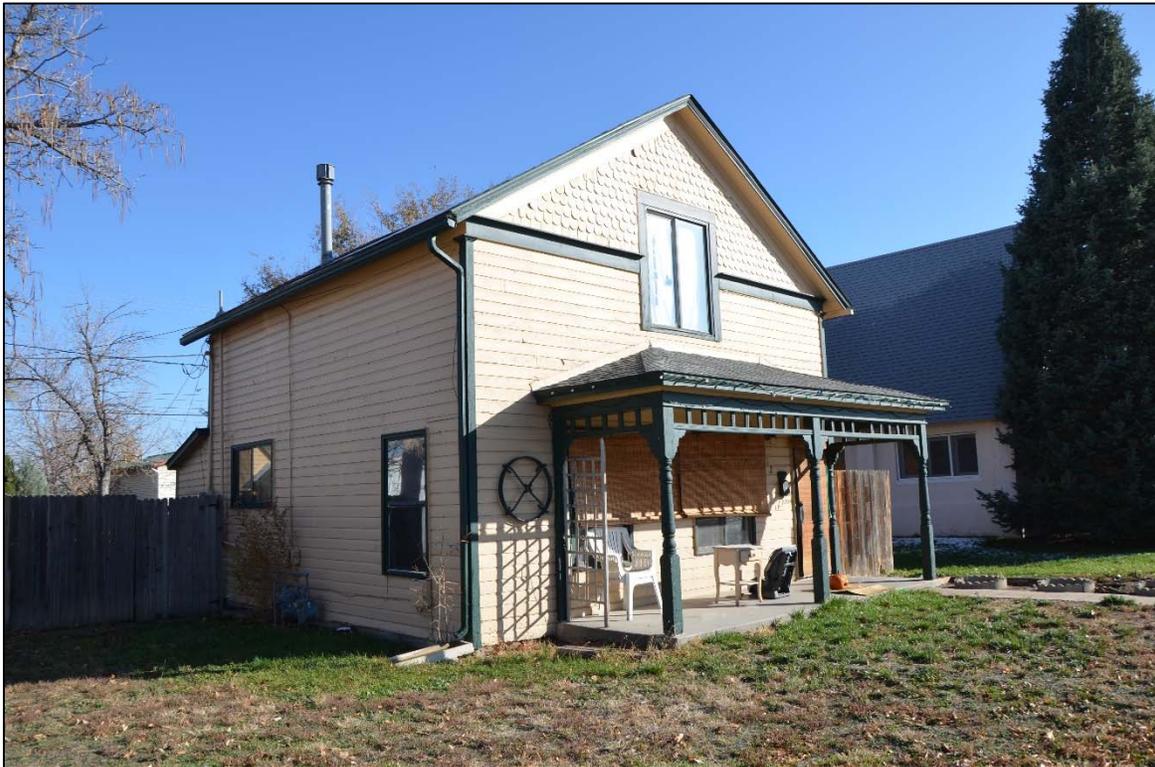
Figure 17. 212 Park Avenue.

This house was constructed ca. 1900, with the rear addition constructed at the same time or shortly thereafter. The window replacement occurred before 1976; a county assessor photograph from that year shows the front gable window was replaced by that time. The roof appears to have been replaced at an unknown date; this may have removed architectural features such as chimneys and decorative elements near the eaves. The carriage house was constructed between 1908 and 1912 (Sanborn Map Company 1908, 1912).

A tall wood fence extends around the backyard; visible elements of landscaping on the property include a grass lawn and mature elm trees in the side yard and backyard. A one- and one-half-story telescoping gable house stands northeast of the house. This building was originally a carriage house (later a garage) that was converted into a residence sometime after 1936 (Sanborn Map Company 1930–1936). The building is clad with novelty siding and sliding windows similar to that on the main house. Building entrances are located on the south and west sides of the building. A small gable roof shelters the west entrance.

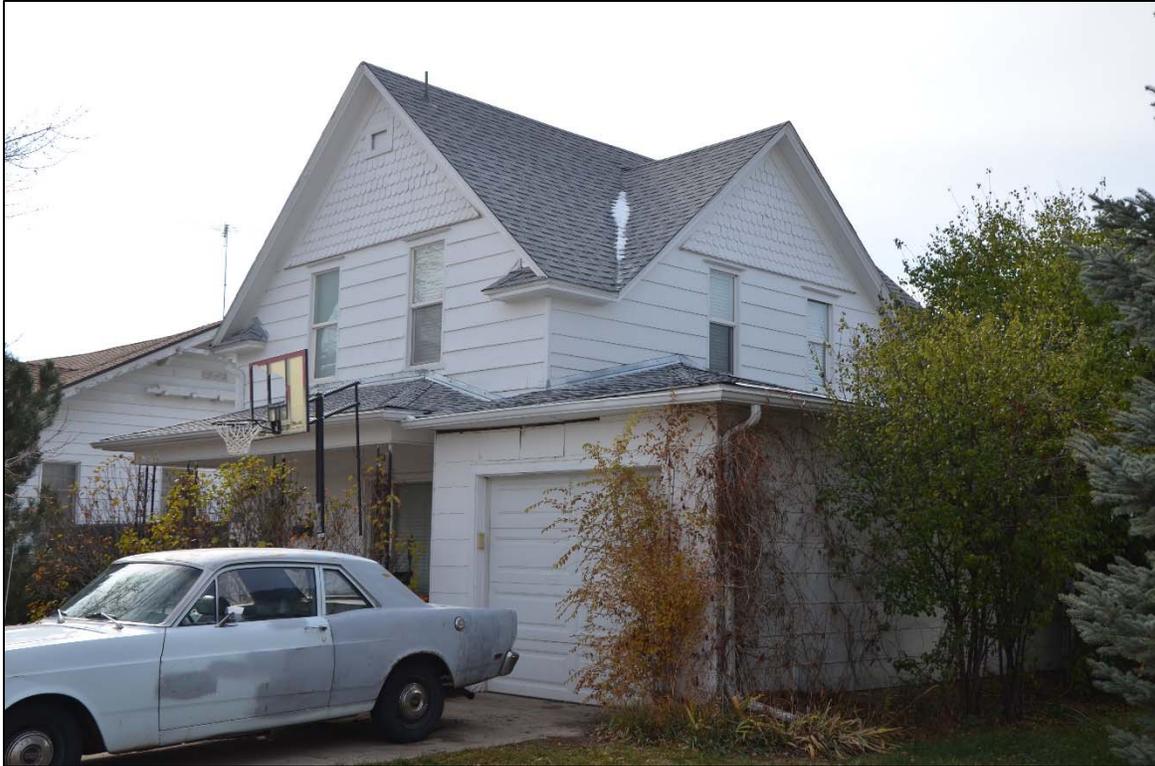
Figure 18. 219 Park Avenue.

This property is associated with the history of residential development in the early twentieth century in Fort Lupton, but lacks integrity. The form of the roof and the fishscale shingles in the gable ends are the only remaining original features on the exterior of this building; all siding (with the exception of the fishscale shingles) has been replaced, all windows have been replaced, the front porch has been seriously altered, and other additions have altered the form of the building. These alterations have caused loss of integrity of design, materials and workmanship. This property does not retain sufficient integrity to convey its significance and is not considered eligible for the NRHP as an individual property. Due to extensive alteration to the building, it lacks sufficient integrity to be a contributing resource to a district.

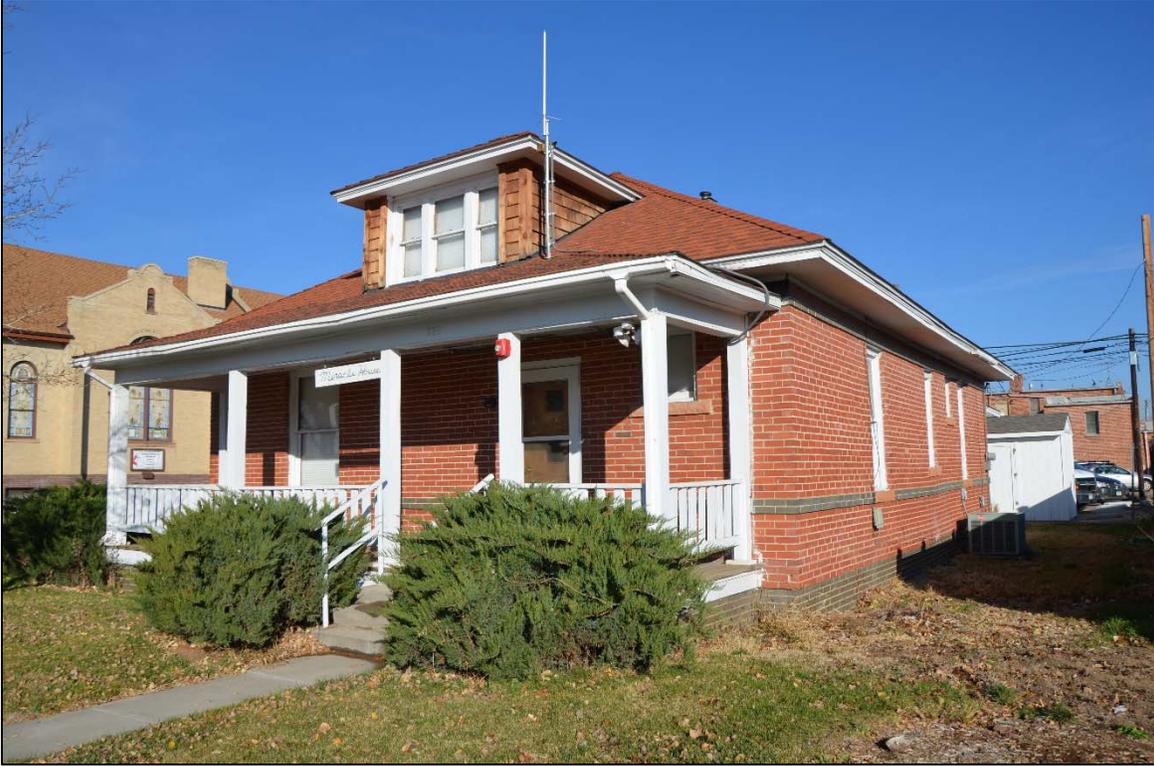
Figure 19. 236 Park Avenue.

This Classic Cottage-style residence is a one- and one-half-story hip-roofed house with hipped dormers on the west and north sides of the roof (Figure 19). The building was originally designed as a classic cottage, with Doric porch posts and details on the front (west) dormer; these details have been removed and replaced with other materials. The building is wood-frame construction with a brick veneer comprising the majority of the exterior cladding, with the exception of the dormer walls, which are clad in wood shingles, and a single-story, hip-roofed enclosed porch on the east side of the building, which is clad in vinyl siding. The majority of the veneer is standard red brick, but the foundation is covered in dark brown brick, with a sill course surrounding the building in the same brick. A second course of the same brick continues around the building directly above the windows. Windows on the building are all the original one-over-one double-hung wood sash, with two single-light fixed or hopper windows near the west end of the north wall. All windows on the brick portion of the building feature red sandstone sills. Smaller one-over-one sash windows light the north and east sides of the enclosed porch. The front door is a three-light wood door visible in a 1976 image of the house. A wheelchair ramp provides access to the back entrance.

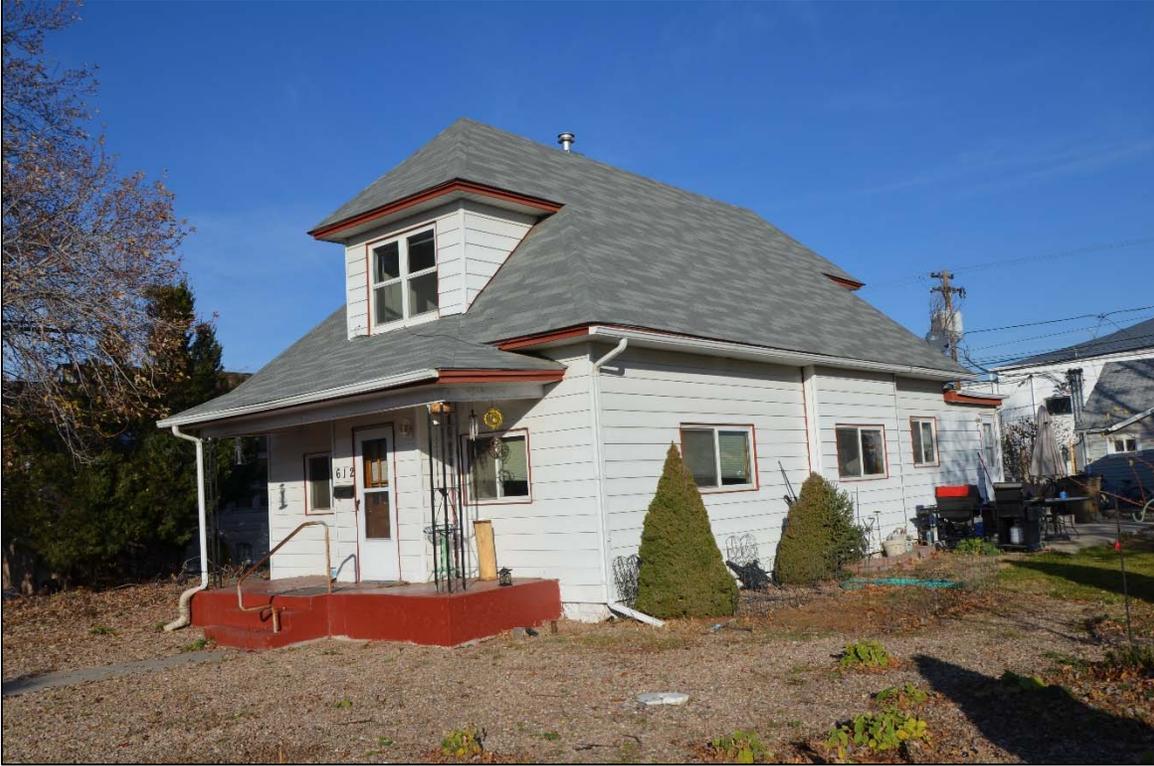
Figure 22. 612 Park Avenue.

This house is associated with Criterion A for its contribution to the late nineteenth century residential development of Fort Lupton. The design of the building is unusual, particularly the steep pitch on the hipped roof. However, alterations to the cladding material and the windows have caused loss of integrity. Further investigation is also warranted for the apparent use of the property as a rooming house in the 1940s.

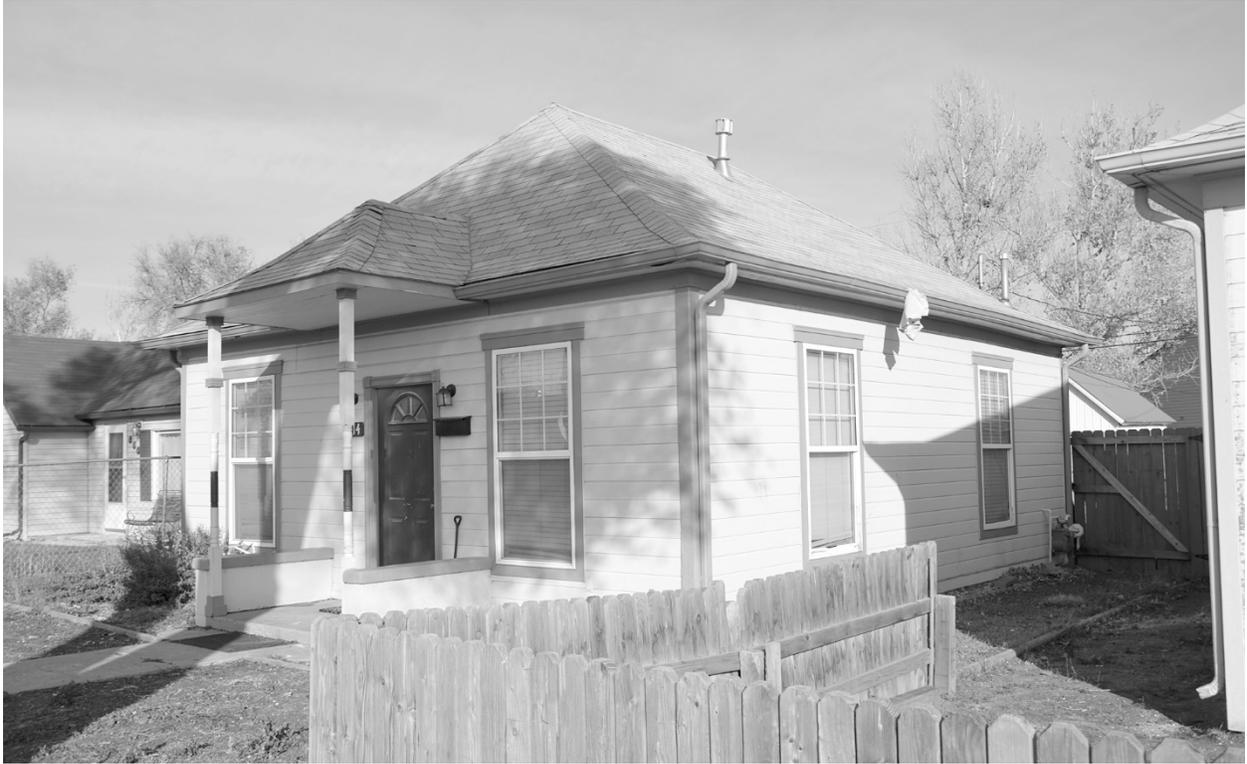
DSC_0475_414Harrison. Southwest corner of building with main façade on left; view to the northeast. All building material except the building corner boards are replacements of original material.

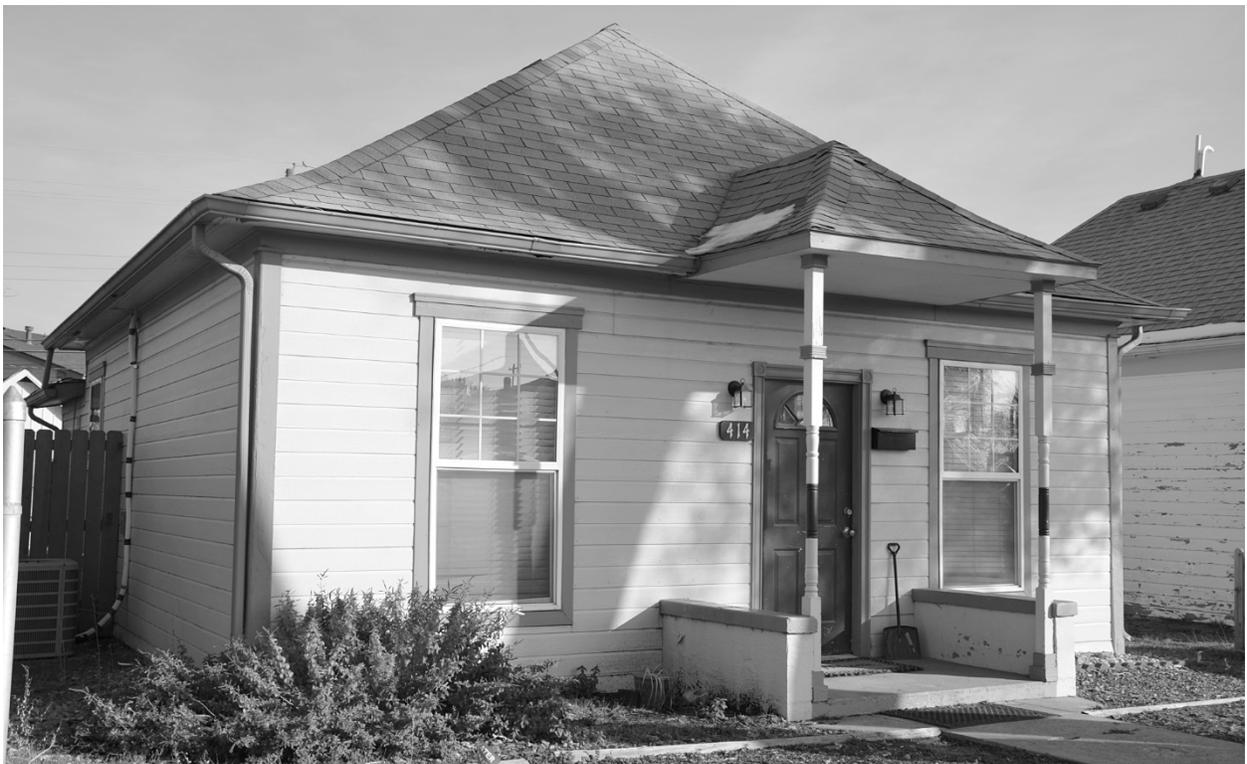
DSC_0477_414Harrison. Main façade showing exterior cladding and window replacements and porch roof and corner post addition; view to the southeast.

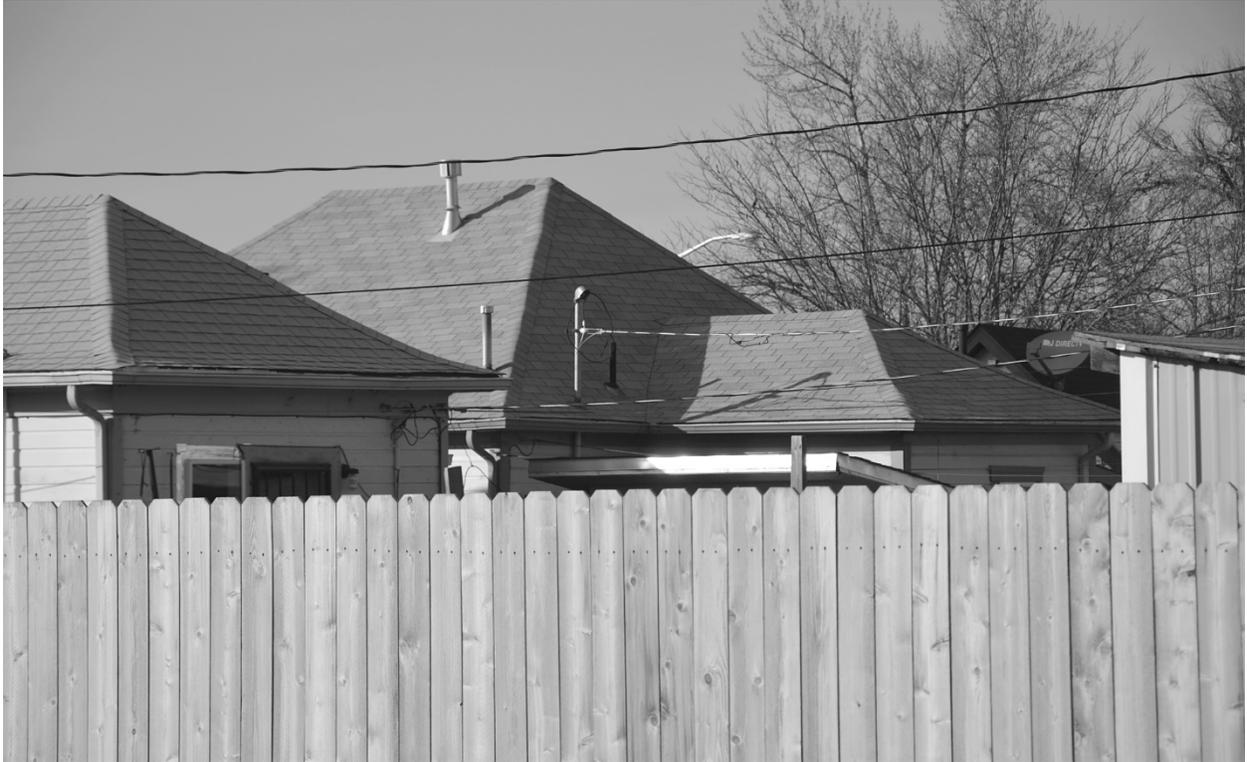
DSC_0482_414Harrison. Southeast corner of house, showing rear wing (rear wing of 408 Harrison in foreground on left); view to the northwest.

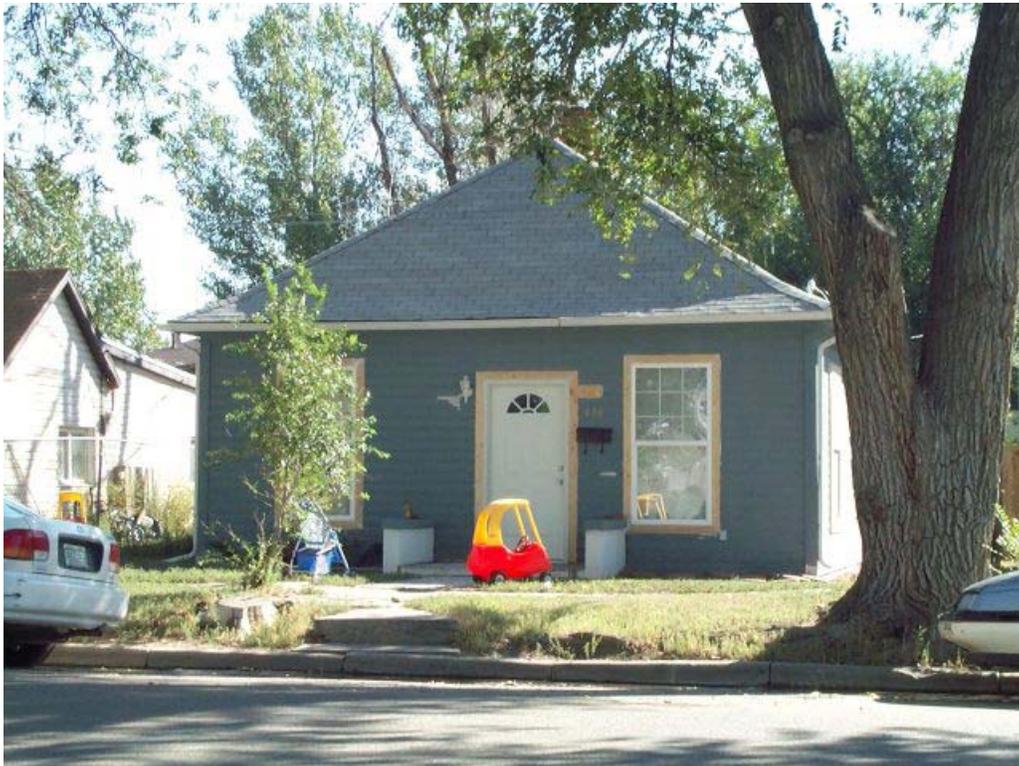
Assessor_R7854899. Weld County Assessor photo of house following replacement of windows and door, but prior to construction of porch addition. Date of photo unknown; post-1995 (Weld County Assessor 2017).

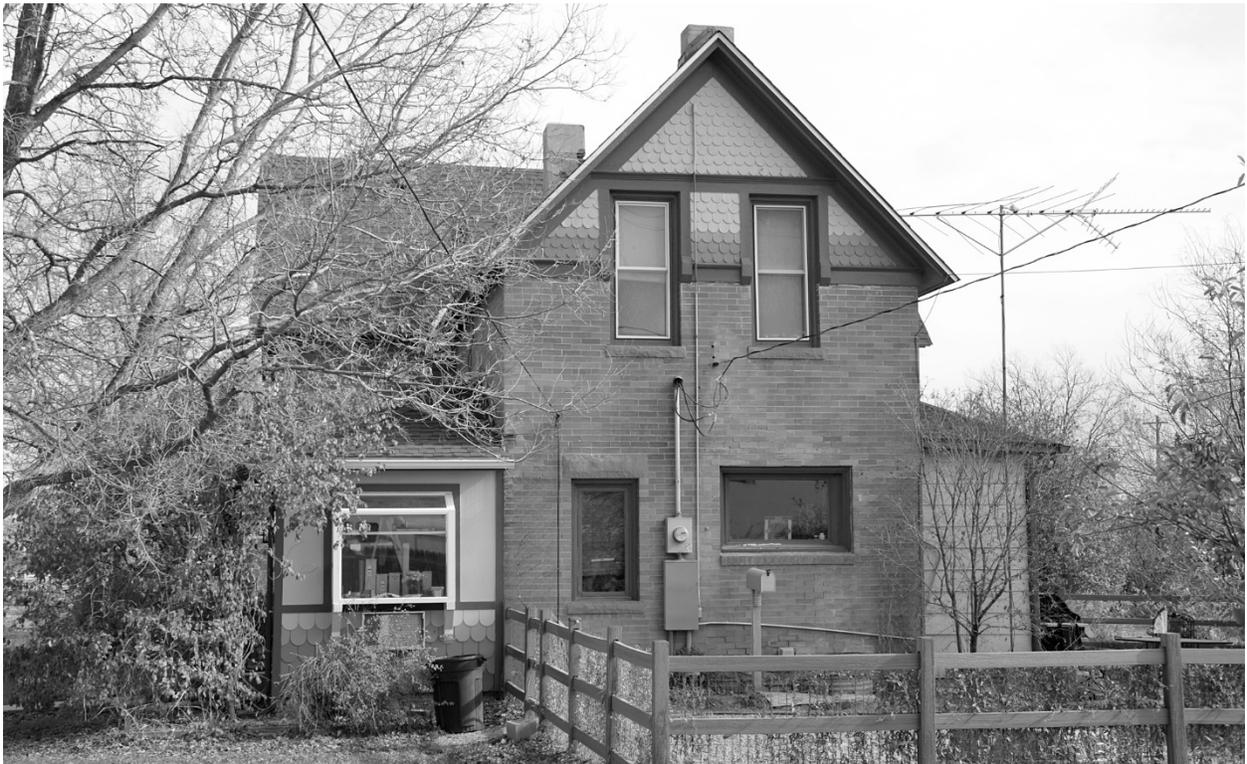
DSC_0389_153Park. Rear façade of house showing window replacements; view to the east.
